December 8, 2023

Ms. Brenda Golden
SAU 95; Windham School District
19 Haverhill Road
Windham, NH 03087

Re: Periodic Indoor Air Quality Testing
Golden Brook School
RPF File 23.0294

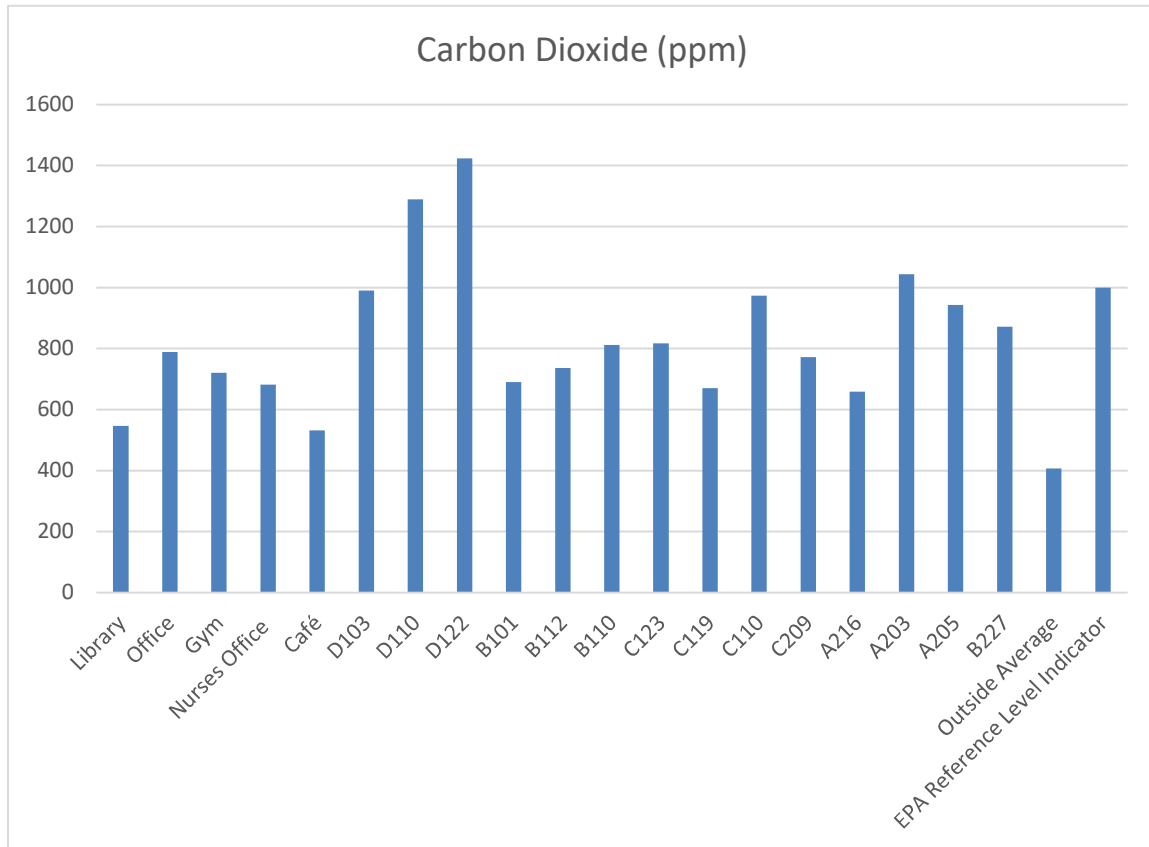
The CO₂ results and testing locations are presented in Appendix A. CO₂ levels at all indoor locations tested were documented in the range of approximately 532 to 1,423 ppm, which is well below the Occupational Safety and Health Administration Permissible Exposure Limit (OSHA PEL) of 5,000 ppm. These concentration ranges are within or below the generally accepted guideline limit of 800 to 1,000 ppm, except for readings collected in rooms D110, D122, and A203 which were elevated above the generally accepted guideline.

The American Society of Heating, Refrigerating and Air Conditioning Engineers (ASHRAE) recommends a guideline in their Standard 62-2001 for Ventilation for Acceptable Indoor Air Quality for a maximum of 700 ppm CO₂ above outside air concentrations as a value under which employee complaints are minimized. On the day of this testing, the outdoor ambient concentration of CO₂ was recorded at 407 ppm with a corresponding value of 1,107 ppm, for a maximum CO₂ for perceived acceptable air quality.

The feasibility of modifying the existing HVAC units to introduce more FOA should be investigated. Measurements to determine ventilation rates were not completed as part of this initial scope of work.

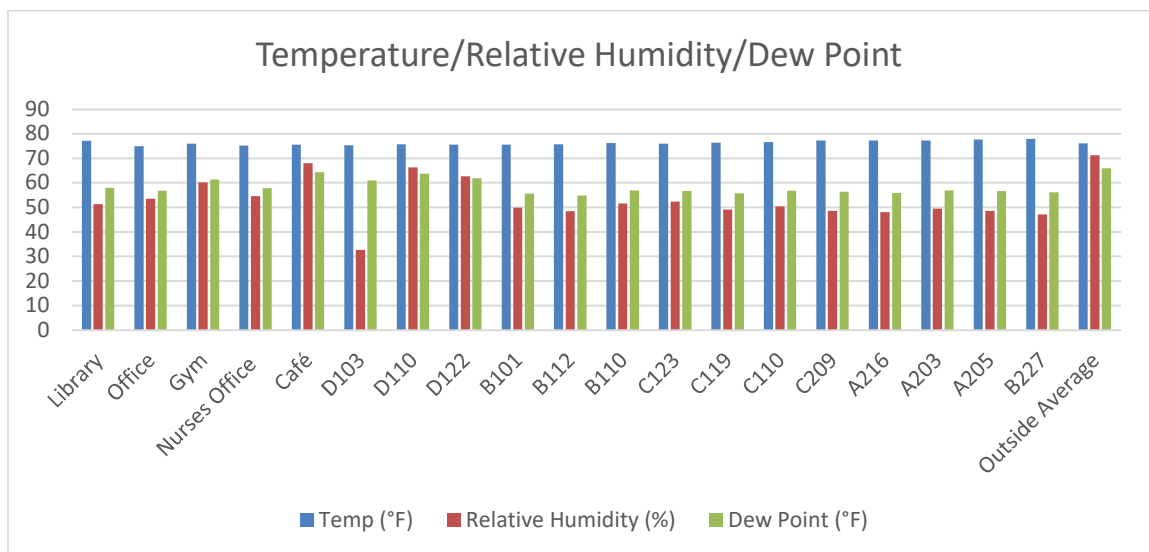
Temperature will affect the occupant's perception of IAQ based on employee comfort levels, effect of drafts or airflow, and humidity levels in a building. In most cases, simple adjustments to thermostats and direction of airflow from registers can improve perceived IAQ. As a reference, the temperatures recommended by ASHRAE for general office space ranges from approximately 68° to 75° Fahrenheit in the winter, and from approximately 75° to 80° Fahrenheit in the summer. Temperature readings at all indoor locations tested were documented in the range of 74.9° to 77.9° Fahrenheit.

The amount of water vapor that can be contained in the air varies by the temperature and pressure of the air. The ratio of water vapor in the air to the maximum amount of water vapor the air can hold at a given temperature is expressed as relative humidity (RH). The recommended RH comfort range is 35% to 55%. In general, for buildings, the presence of excessive moisture can lead to mold growth and other biological contaminants. Low RH, common for buildings in New England during colder months, may contribute to irritated mucous membranes, dry eyes and sinus discomfort while high relative humidity, common in summer, may cause discomfort, as it hinders the body's use of perspiration as a cooling mechanism. RH levels at the indoor locations tested during this survey were below the generally accepted comfort range, except for readings collected in the gym, café, and rooms D110 and D122 which were elevated above the generally accepted guideline.

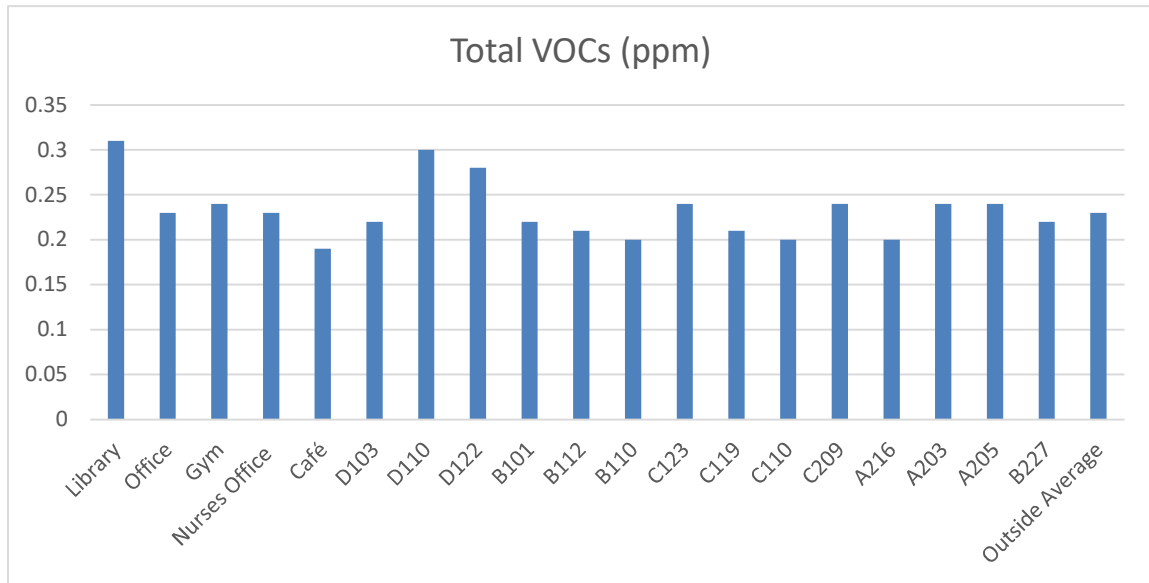
The scope of this survey included screening for total volatile organic compounds (VOCs). During this testing, total VOCs were measured at 0.31 parts per million (ppm) or less for all locations. These readings are within the "normal indoor air" range depicted below and are comparable to the outside air, which had an average reading of 0.23 ppm. These results are summarized below and presented in Appendix A.

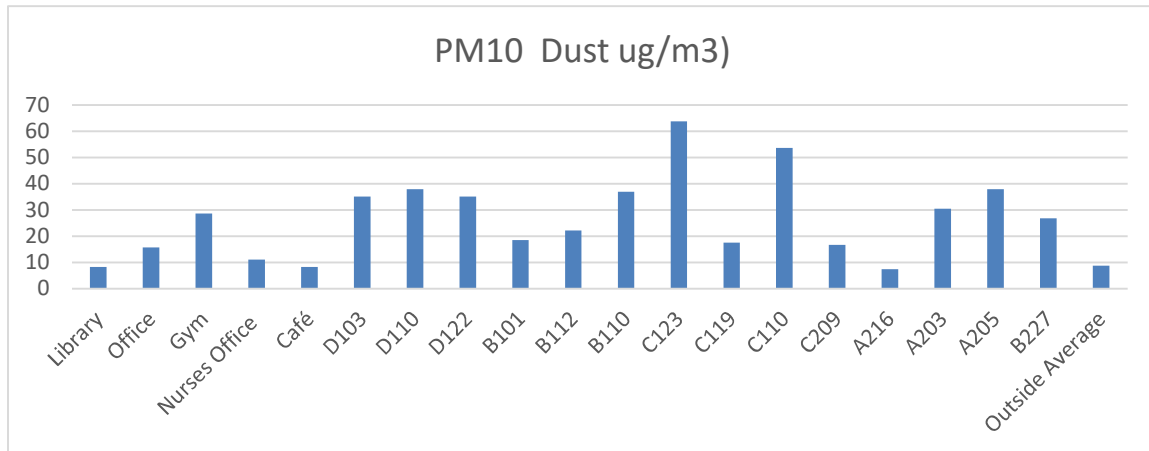
Direct reading determinations for PM₁₀ at all indoor locations tested were in the range of approximately 7.4 to 63.79 micrograms per cubic meter of air ($\mu\text{g}/\text{m}^3$). The results at most of the interior locations tested were elevated above the values found outside, which was approximately $8.79 \mu\text{g}/\text{m}^3$. The US EPA does have a National Ambient Air Quality Standard at $150 \mu\text{g}/\text{m}^3$ which was not exceeded during the testing. The World Health Organization (WHO) also has set a standard of $50 \mu\text{g}/\text{m}^3$ as a 24-hour average and $25 \mu\text{g}/\text{m}^3$ as an annual average exposure. These results and testing locations are presented in Appendix A.

These results indicate that the HVAC filters are not reducing the overall particle loading inside the building when compared to the outside air. For a building that implements the use of an HVAC system, it is typical to see a 25% to 35% reduction in total particulates inside a building compared to the outside concentration of particulates while the HVAC units are operational. The feasibility of upgrading the HVAC systems' filter efficiency rating could be investigated if complaints were to increase at this building. The American Society of Heating, Refrigeration, and Air Conditioning Engineers (ASHRAE) has recommended filter minimum efficiency reporting value (MERV) of not less than six (6) for filters in HVAC systems supplying air to occupied office space (ASHRAE Standard 62.1-2004-5.9). Follow the manufacturer's recommendations for a filter change out schedule.

Other steps to reduce indoor PM₁₀ concentrations include proper ventilation, away from HVAC intakes, of combustion appliances to the outdoors, proper exhaust vents in cooking areas, proper use of wood stoves, and professional maintenance of heating systems.
